# Reconditioned EGR Valves

## “Turn old into new” does not apply here

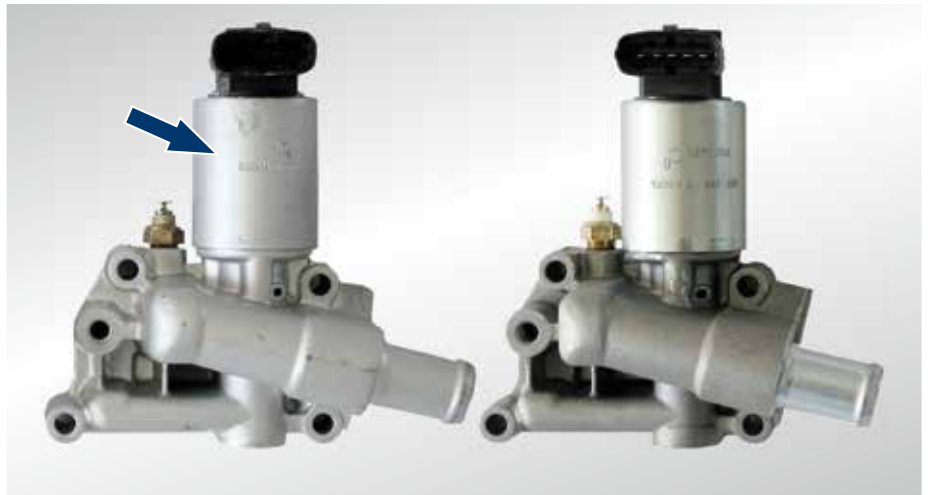
The result may look top-quality, but says nothing about the functioning of the EGR valve (Fig. 1).

Image 1: A painted EGR valve (arrow) looks like new – but it is not.

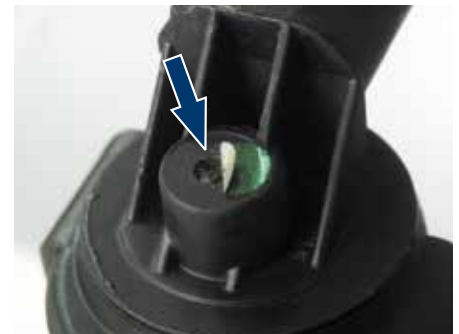
Image 2: For reconditioning, the coil body was drilled open, the inside of the coil was pushed out and cleaned. After re-assembly, the bore was glued and covered with a sticker. Coil and armature may have been damaged when they were pushed out. Water can enter through the hole and cause damage.

Image 2: This bore (arrow) can lead to water penetration and failure.

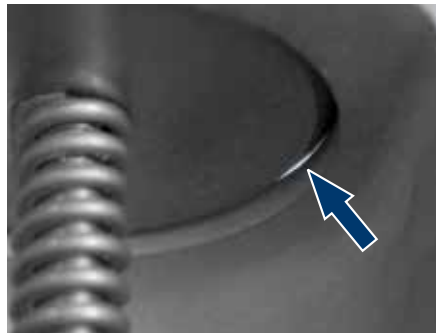
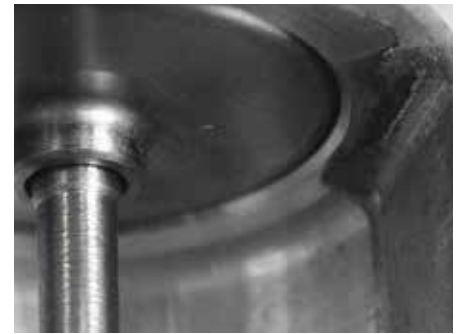
Often, conditioned parts of different generations of an EGR valve can be supplemented with components that have been made by the reconditioner himself. This may cause the processed EGR valves to no longer fit for the intended vehicle application, or they may cause problems in the vehicle. The original, especially shaped valve seat is supposed to provide a tight seal.

*Image 3: A leaky valve seat (arrow) causes problems.*

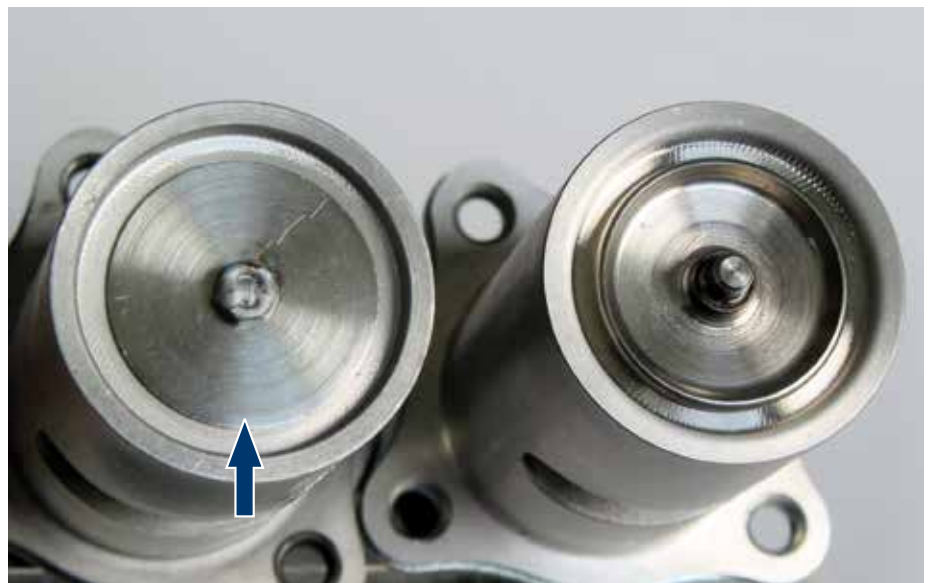
If the valve head is replaced by a simple plate as in image 4, correct sealing is no longer provided. This leads to uncontrolled exhaust gas recirculation. Out-of-true idling, poor acceleration, or even limp home function can be the result.

*Image 4: A welded-on metal plate (arrow) is not a substitute for a valve seat.*

We recommend using only new EGR valves. The potential price advantage with reconditioned EGR valves compared to a new part is eliminated by a shortened product life and thus more frequent servicing costs.

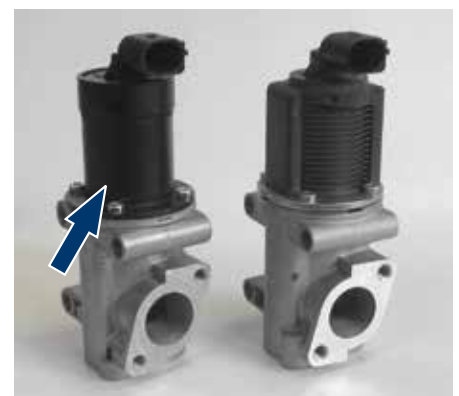
Coil housings especially optimized for heat dissipation are replaced with simple turned parts (image 5).

*Image 5: Original coil body was replaced by simple turned part (arrow).*
