Service Engineering Bulletin

SB2136 (Page 1 of 2)

Diesel Engine Oil Consumption

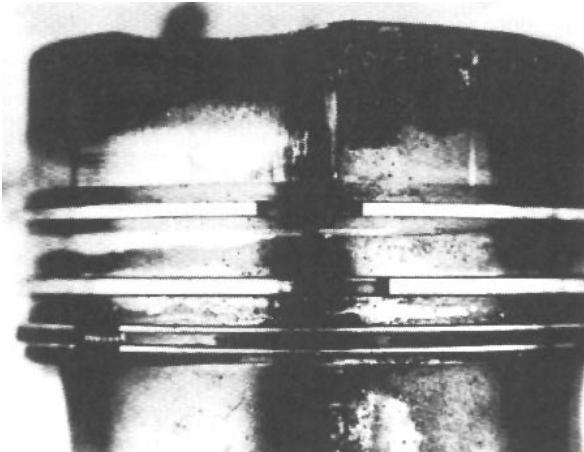
The small increase in thermal load above critical level appears to have been the determining factor.
It has been determined that bore polishing in excess of 20% will lead to increased oil consumption.

Cylinder bore polishing arises from the excessive deposits of hard carbon on the piston top land (Fig. 1). Bore polishing tends to be self-evident. It is characterised by a bright, smooth "mirror-like" surface with elimination of the crosshatch-honing pattern (Fig. 2). The photographs show a cylinder liner and its mating piston, vividly illustrating the bore polishing condition present on the thrust faces.

The S.H.P.D. Oils previously mentioned and available from major oil companies are to be recommended for their ability to prevent cylinder bore polishing and show significant oil control advantage.
