Timing belt/kit installation on GM (Isuzu) 1.7D engines

GATES REFERENCE: 5563XS/K015563XS/K025563XS/K035563XS

ENGINE: Isuzu 1.7 DTI

ENGINE CODE: A17DT, A17DTR, Y17DTH, Y17DTL, Z17DT, Z17DTH, Z17DTR

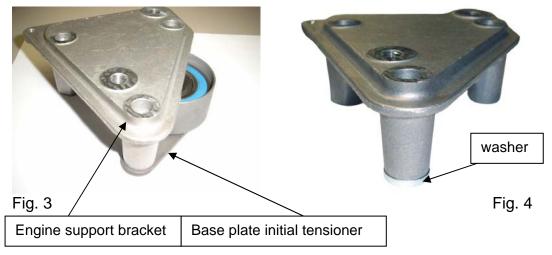
As the initial tensioner base plate was sitting under one of the legs of the engine support bracket (Fig. 3), K015563XS can only be used from engine nr 328704 on.

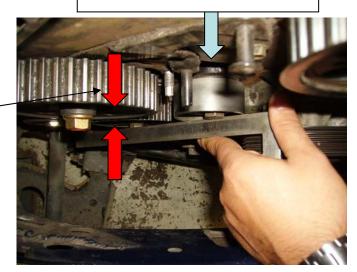
Fig. 6

4) Install new coil spring tensioner (spring over stud, bolt hand tight); make sure tensioner is sitting perfectly against engine block. If not, the spring could end up between the tensioner and the engine block, creating a serious tensioner misalignment (see Fig. 6)

Spring trapped behind tensioner

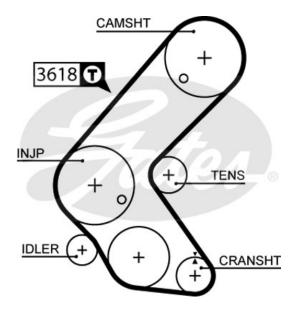
Fig. 7

(see drive system layout below - Fig. 7) using the Gates Sonic Tension Tester STT-1.

To do this, enter the code 3618 in the STT-1 (ensure chip version 006 is installed) and measure in the normal way. If the tension is too high then the tensioner should be completely released and tensioning procedure repeated until the green light is obtained.

If the tension is too low then it will be necessary to assist the tensioner spring with the Allen key; until the green light is obtained.
