Technical Bulletin

VAG 2.5 V6 TDI – Timing Belt set-up.

2.5 V6 TDI

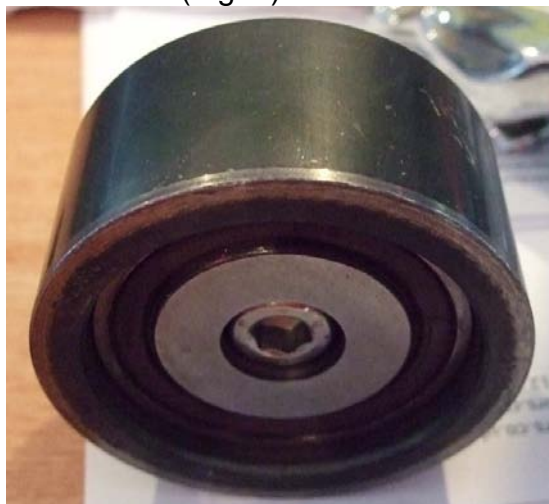
Fig. 6

- 11) Install new idler. **ATTENTION!!!** The idler now has a countersunk hole (Fig 6), needing a shorter bolt (supplied in the kit). Failure to use the correct bolt will lead to incorrect clamping, with a sheared bolt as a result (Fig. 7)

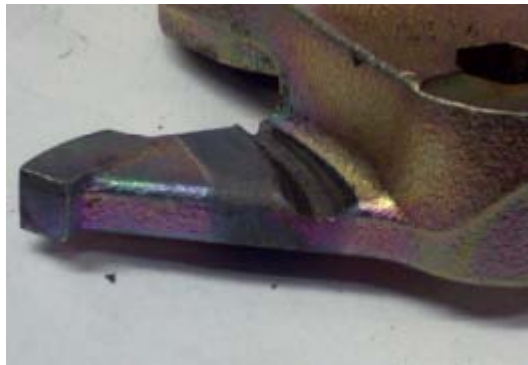
Fig 10

Any incorrect contact of the lever arm with the pin on the tensioner, or lack of washer, will cause serious damage to the system; with belt failure as a result (Fig.10).

Do not forget (1) washer behind lever and tensioner pulley!!
