Technical Bulletin

VAG 2.5 V6 TDI – Timing Belt set-up.

2.5 V6 TDI

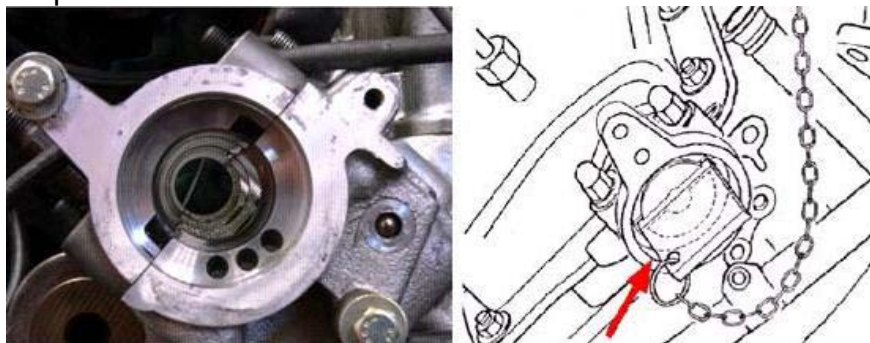
Fig. 5

NOTE: Setting plates **cannot** be used to hold camshafts in place when releasing sprocket bolts. They are only for holding timing position!
